Designation: C1942 – 24

## Standard Practice for Evaluation of Low Angle Light Characteristics<sup>1</sup>

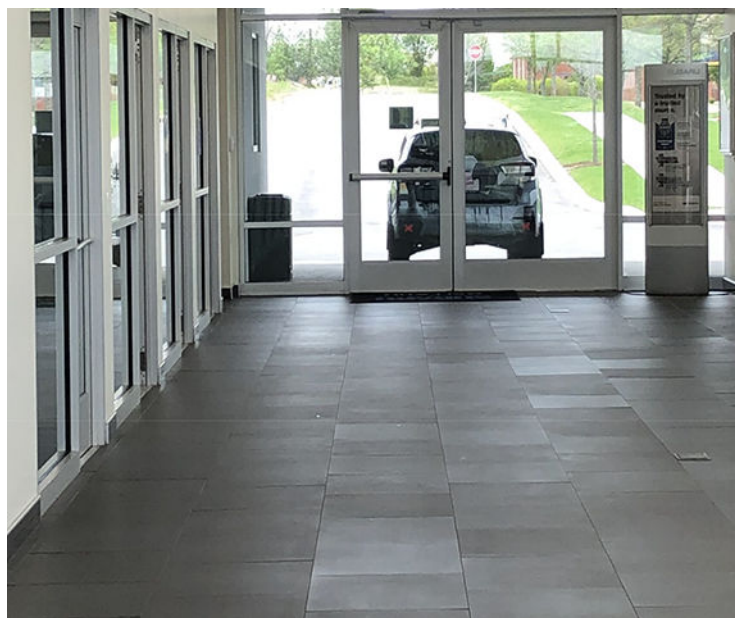
FIG. 1 Low Angle Light Defect Visible in an Installation

3.1.2.1 *Discussion*—When viewed at near vertical conditions (60° to 90°) the defect is typically not detectable. On lower gloss tiles this can be a checkerboard pattern (gloss difference) from tile to tile as shown by Fig. 1. Higher gloss (polished) tiles may exhibit specific defects under these conditions as described in Terminology F109.

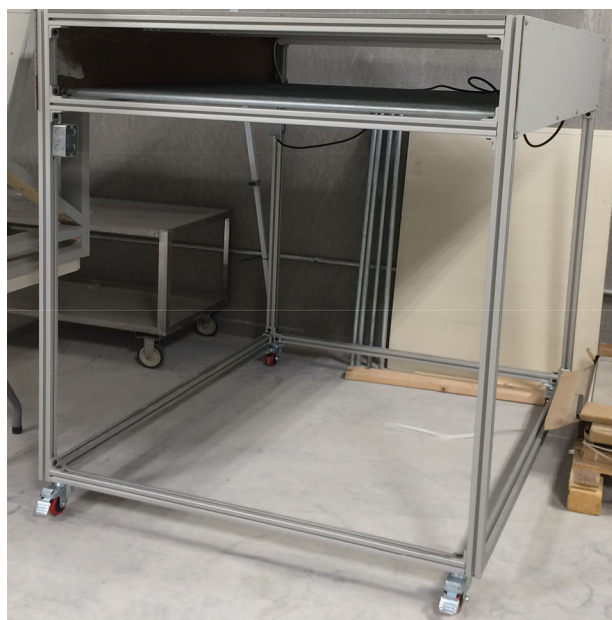
FIG. 2 Low Angle Light Viewing Box

5.2 The box shall be wide enough to accommodate at least two tiles being viewed, so length and width may vary. An opening of 6.0 in.  $\pm$  1.0 in. (127 mm to 177.8 mm) that permits viewing of the product without directly observing the light source. An example is provided as Fig. 2.

5.4 *Light Source*, of sufficient strength to cast a strong diffused, light across the samples from the rear of the box. An 18W LED 24 in. fixture with 1350 lm and a color temperature of 5000 K was found to be sufficient for a 50 in. by 60 in. by 6 in. box shown in Fig. 2.

5.3 The light source shall be placed a minimum of 12 in. behind the rear edge of the tile in relation to the front of the box.
